TECHNICAL INSPECTION REPORT

6 OPERATION CROSSROADS.
U.S.S. BRISCOE (APA65)

TEST BAKER [U]

USS BRISCOE (APA65)

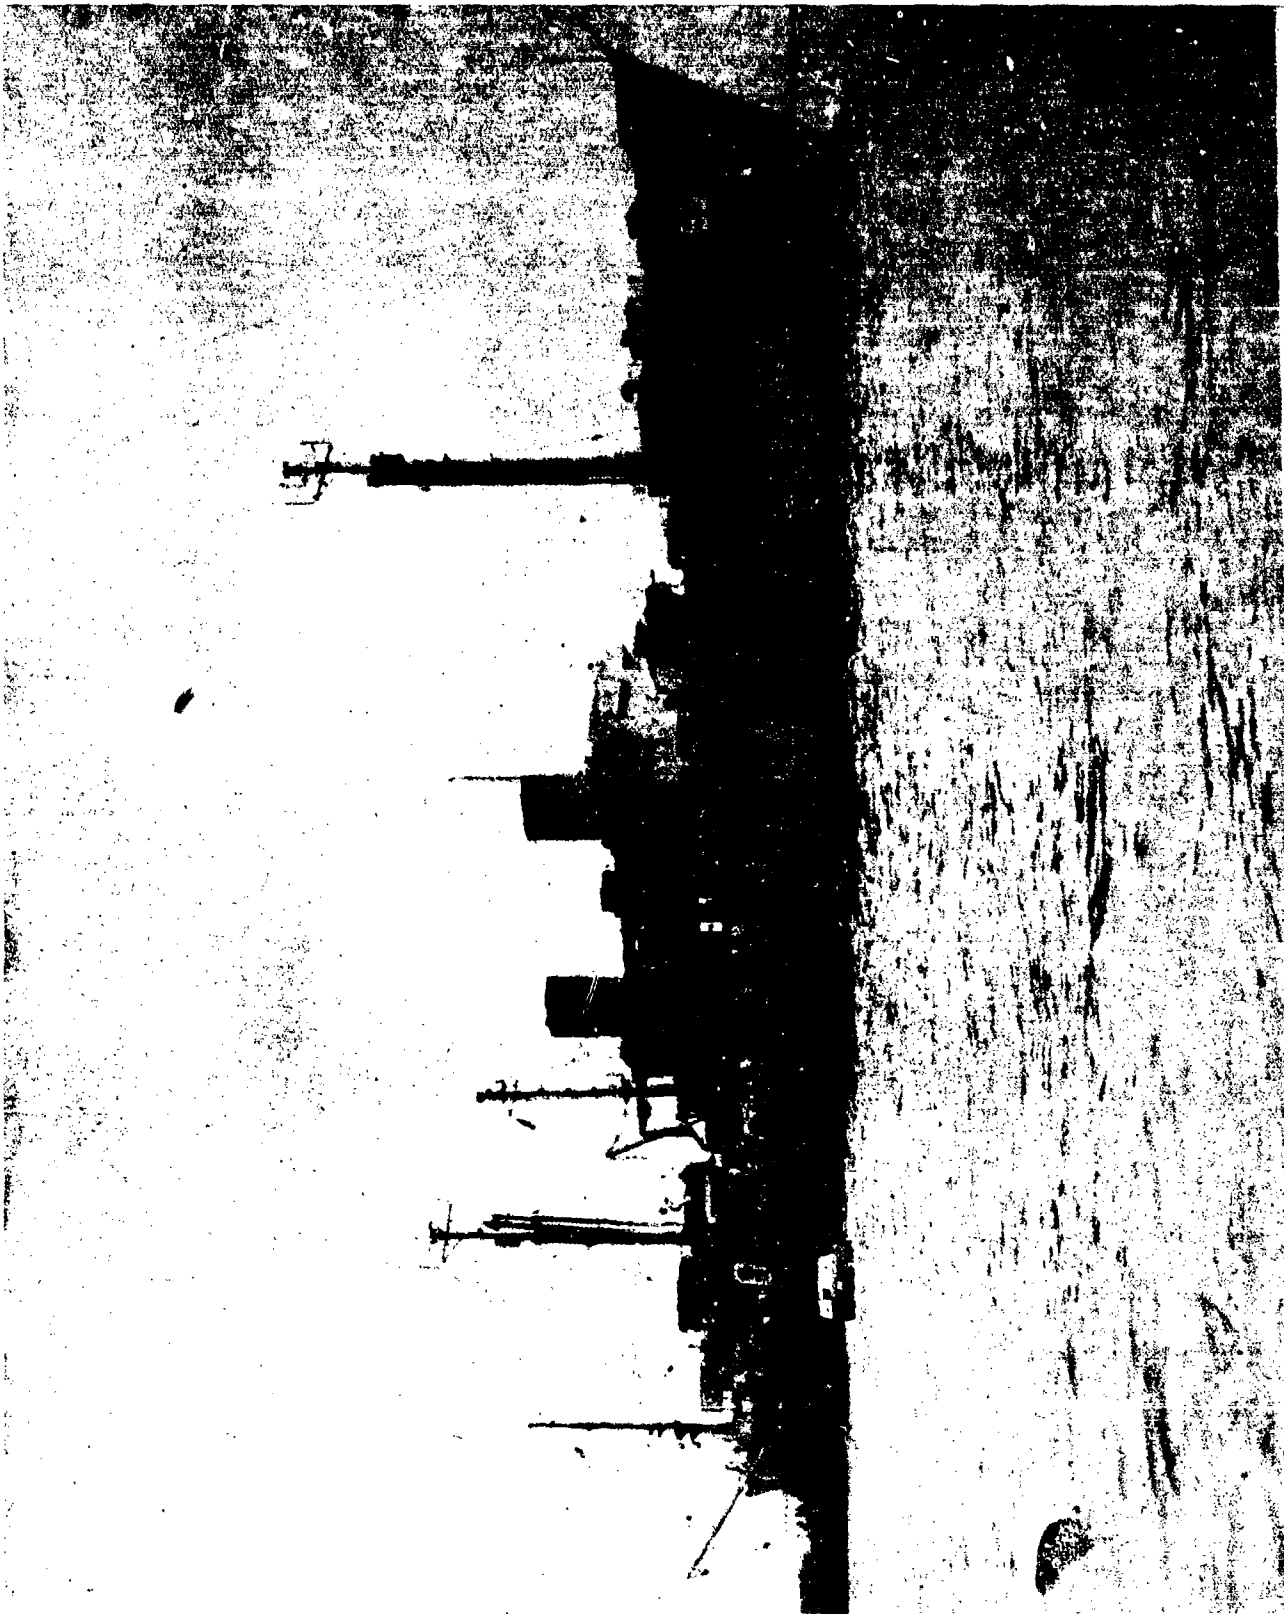
Both flag bags are missing. Bulkheads are dished. Watertight and weather tight doors are dished and some are jammed. The stacks are dished. The upper deck cargo hatch boards are displaced. Many of the boards are creased at their mid-length. The retaining straps for both port and starboard after cargo booms have been carried away. The pontoon covers of No. 2 cargo hatch on the main deck were thrown into the bottom of the hold. In general, all gear not rigidly secured was thrown about.

AB-CR-227-289-62. View from starboard bow after Test B.

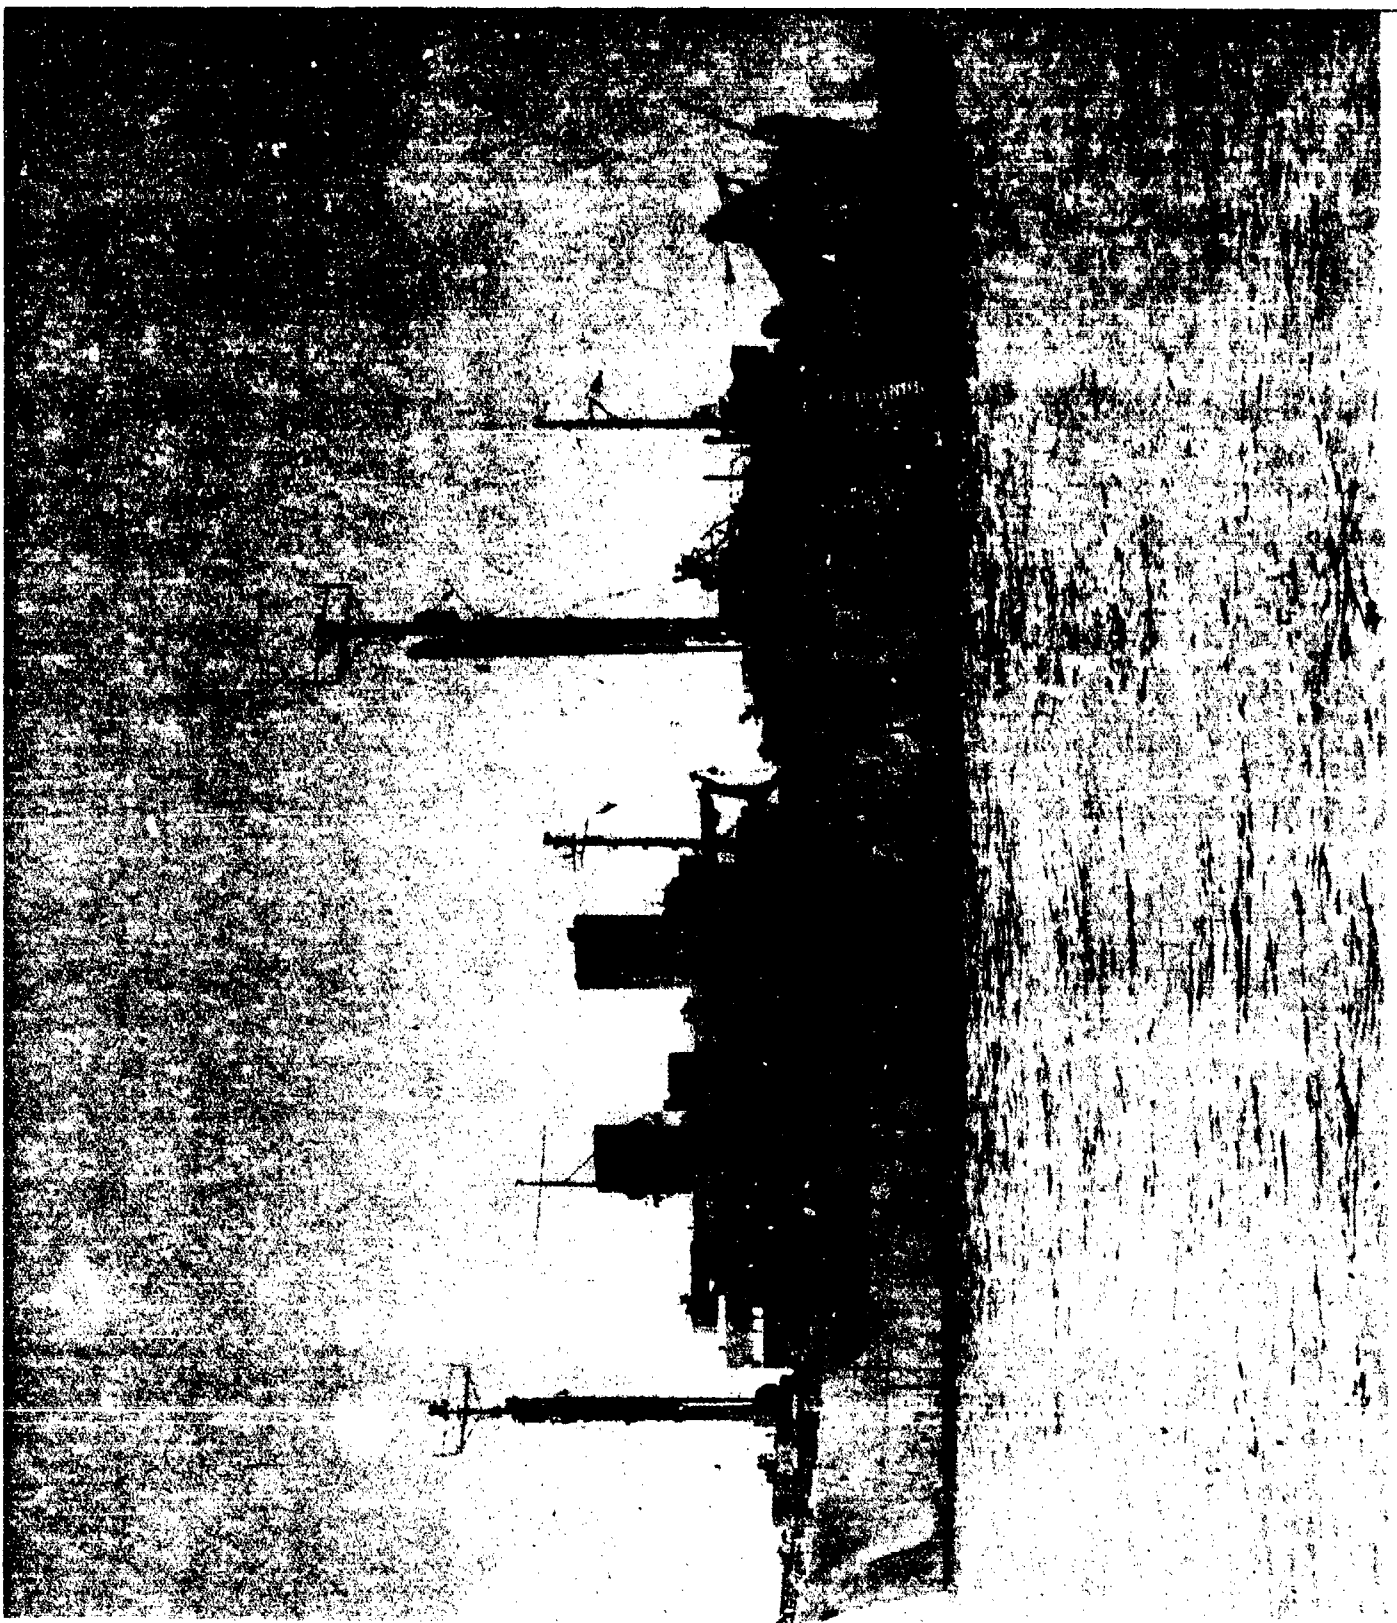
AB-CR-227-289-58. View from port quarter after Test B.

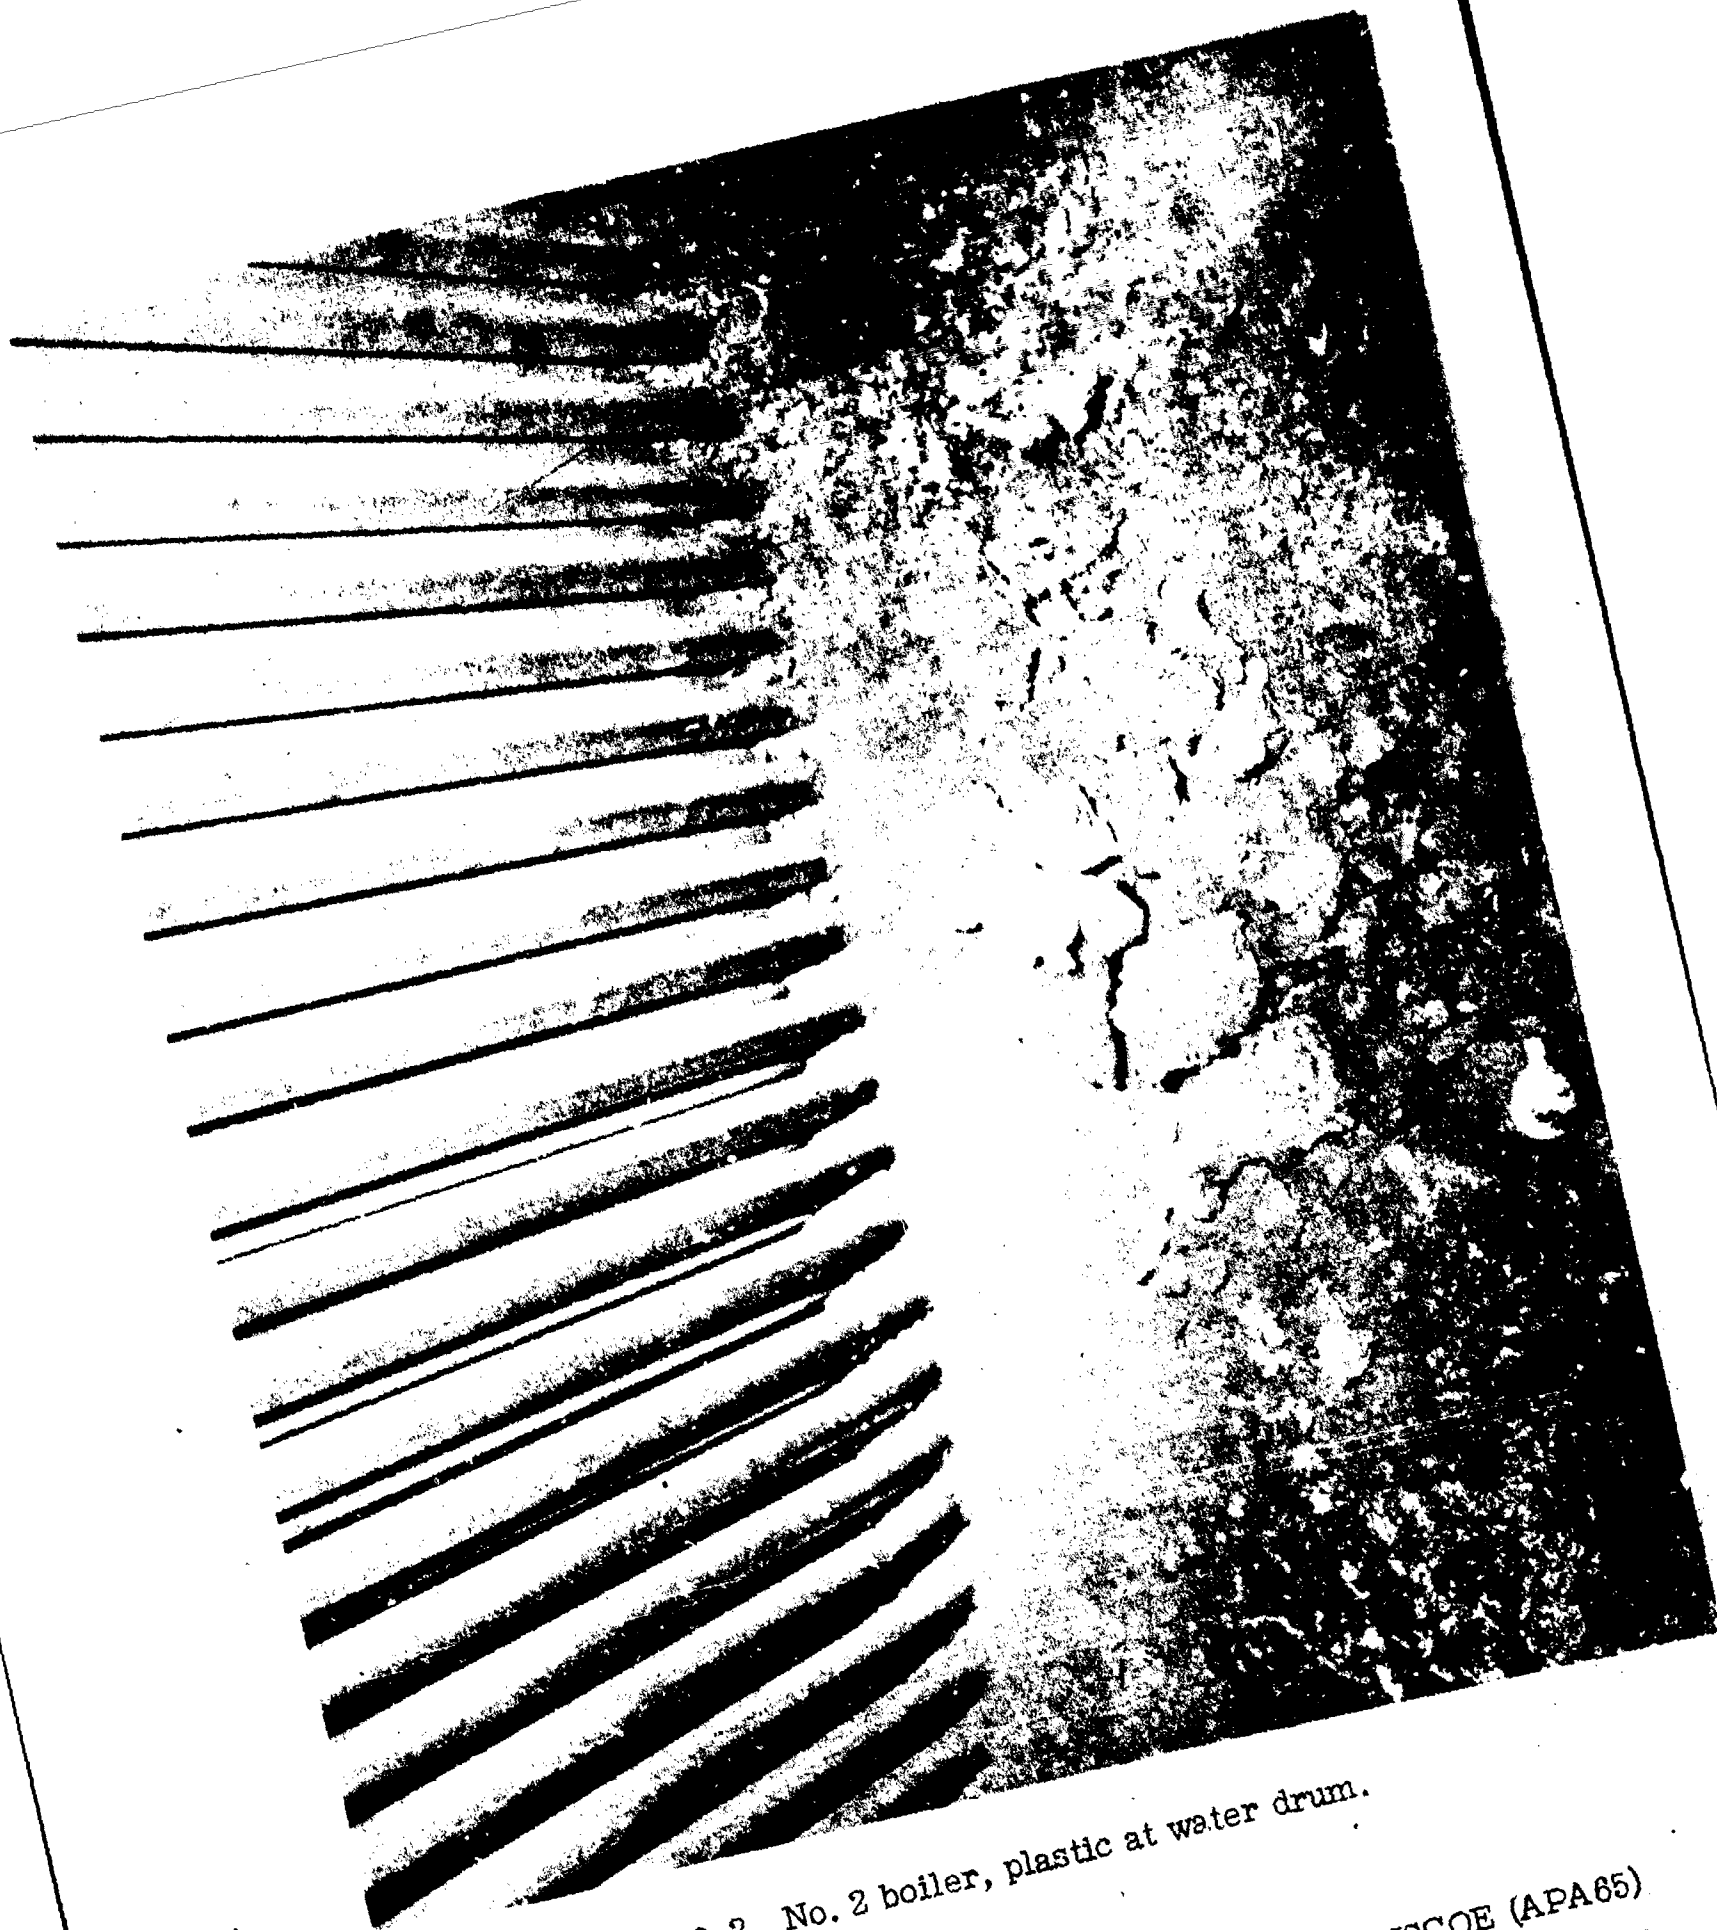
(d) Brickwork and furnaces - The plastic refractory at the water wall headers and around the generating tubes near the furnace floors had cracked off and fallen down. Slag on the walls had spalled, cracked off and fallen to the deck. It is considered that the amount of cracking and spalling of the brickwork was not sufficient to require any reduction in the steaming rate of the boilers and that they could have continued in operation for an extended period without repair. (Photos 4045-12, 1933-1, 2, pages 42 , 43 , and 44).

AB-CR-76-1933-2. No. 2 boiler, plastic at water drum.

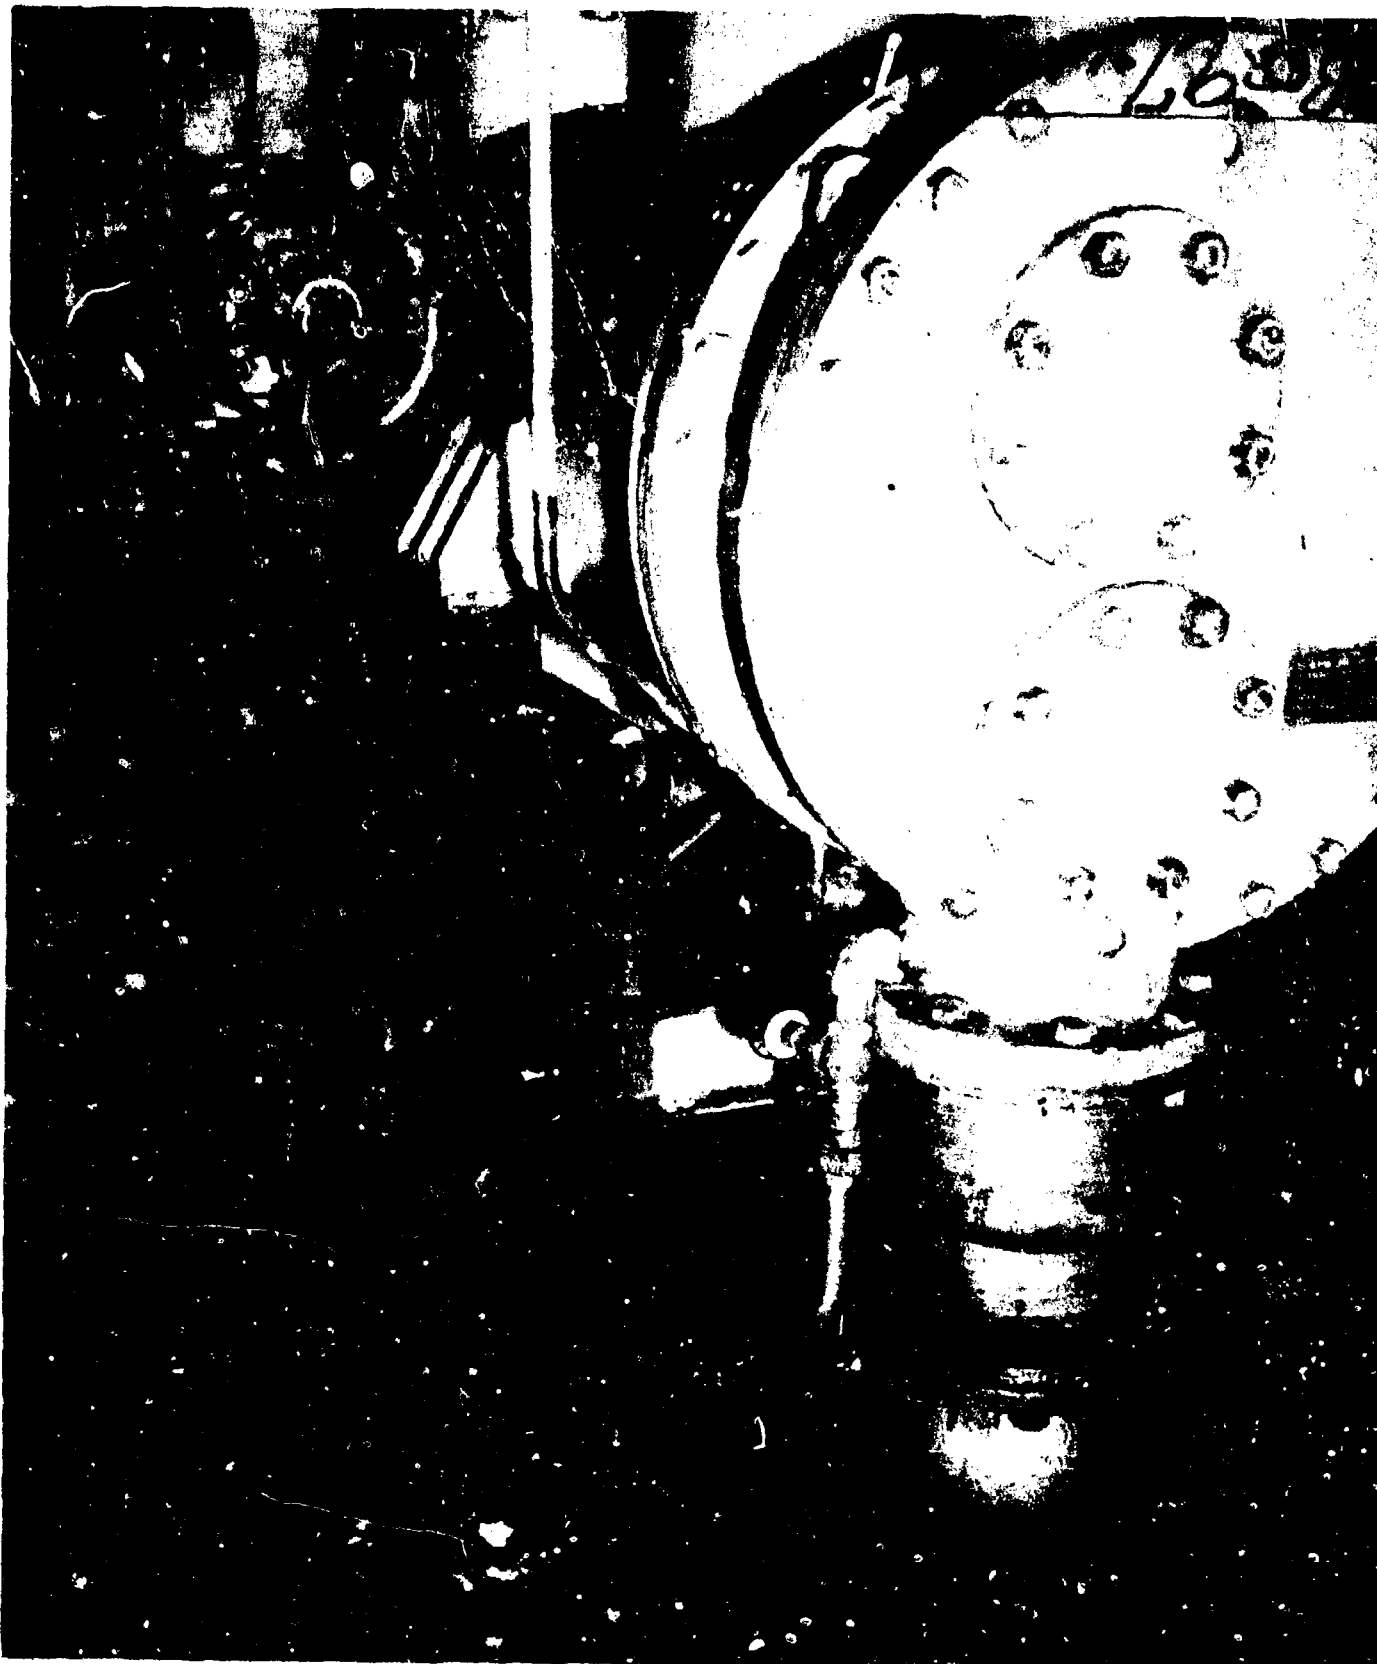
The auxiliary condenser in the forward engine room had shifted slightly on its foundation, and holding down bolts were stretched beyond their elastic limit and were loose, but not broken. See photo 4044-1, page 47 , for full view of condenser and photograph 4044-2, page 48 , for mounting foot.

AB-CR-97-4044-1. Ship's service auxiliary generator, No. 1 engine room.

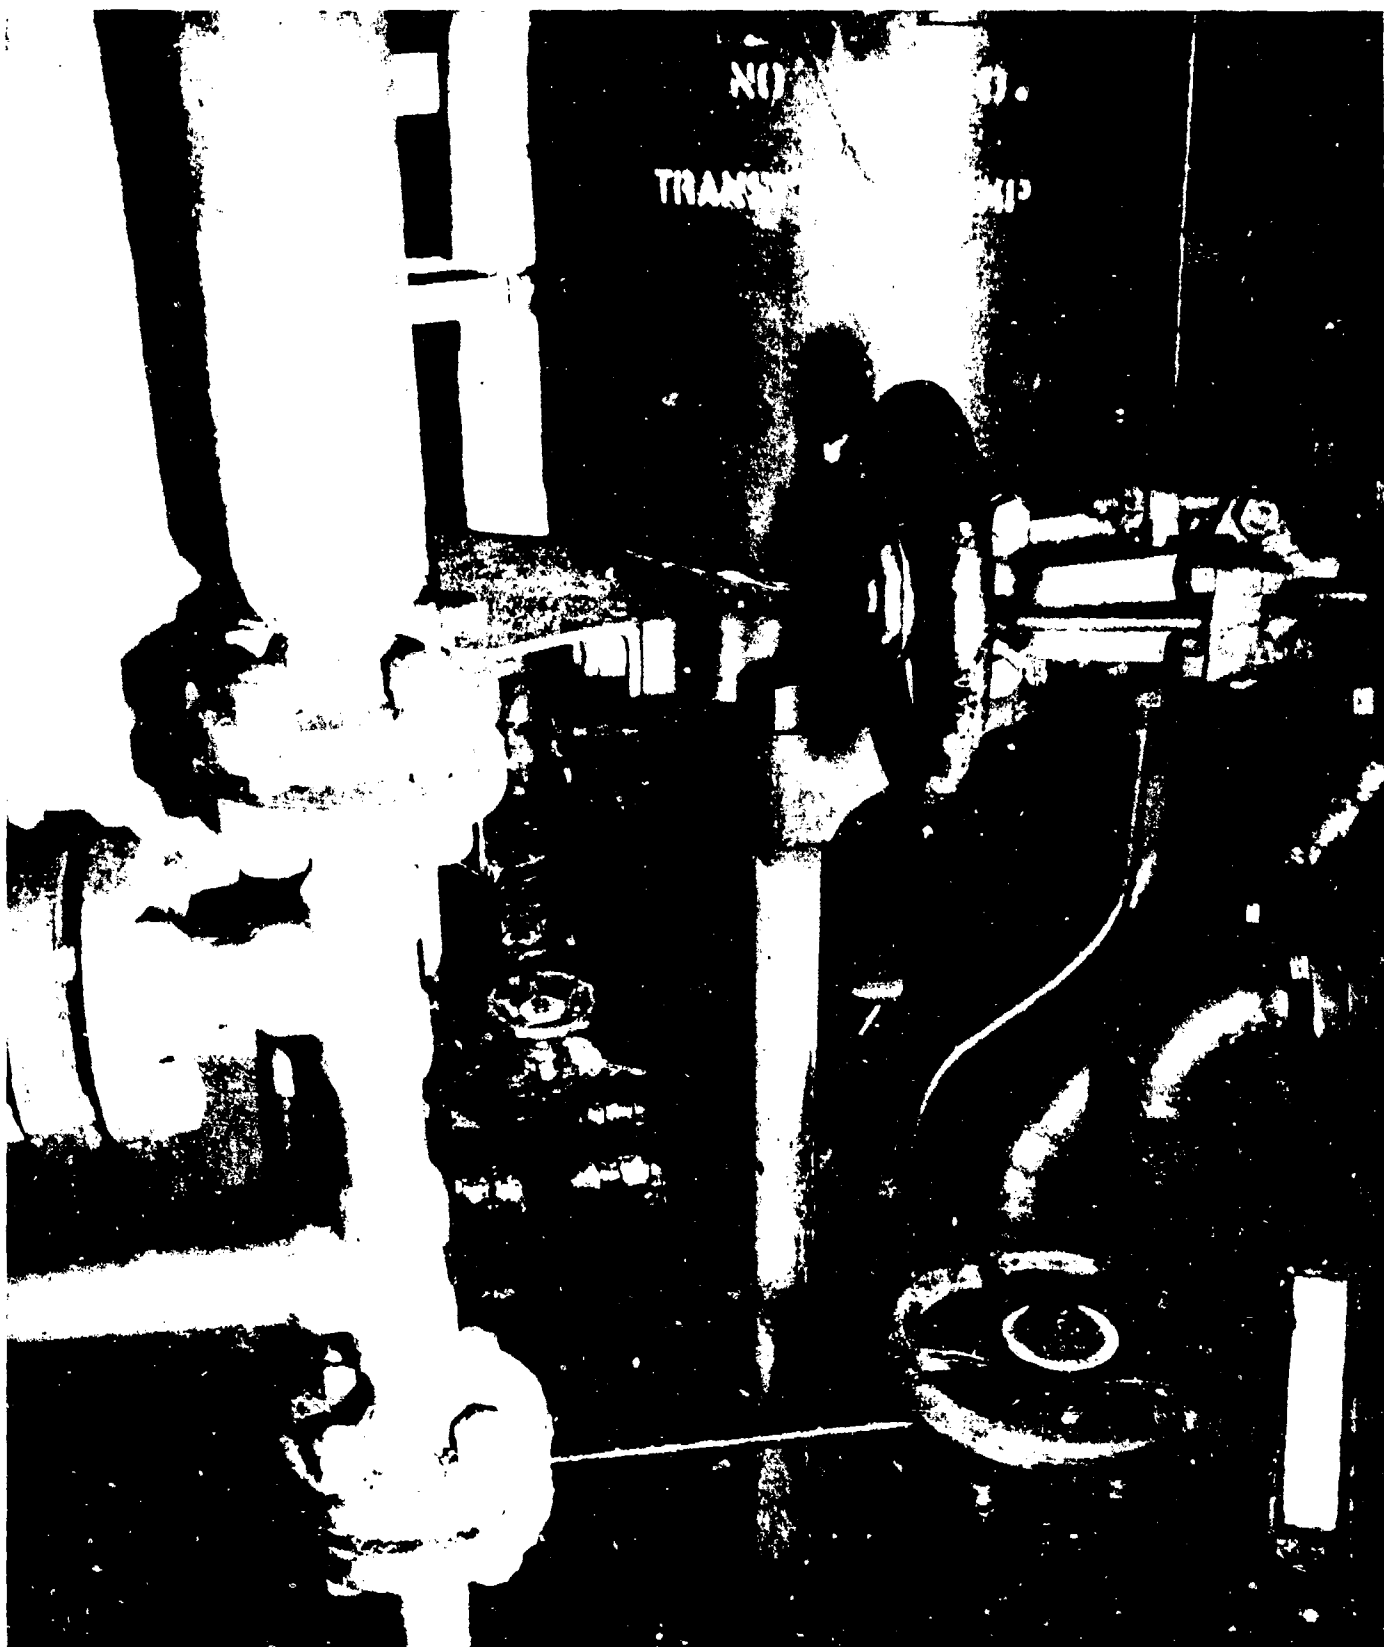
On practically all vertical reciprocating pumps, the bolts securing the steam end to the ship's structure had been stretched and were loose in the holes. In one case, (#1 fuel oil transfer pump) one bolt was missing. Photo 4044-4, page 49 , is of #1 fuel oil transfer pump but may be considered as typical of all vertical reciprocating pumps on this vessel. It is not believed that this would have impaired operability of the pumps.

AB-CR-97-4044-4. No. 1 fuel oil transfer pump foundation bolts.

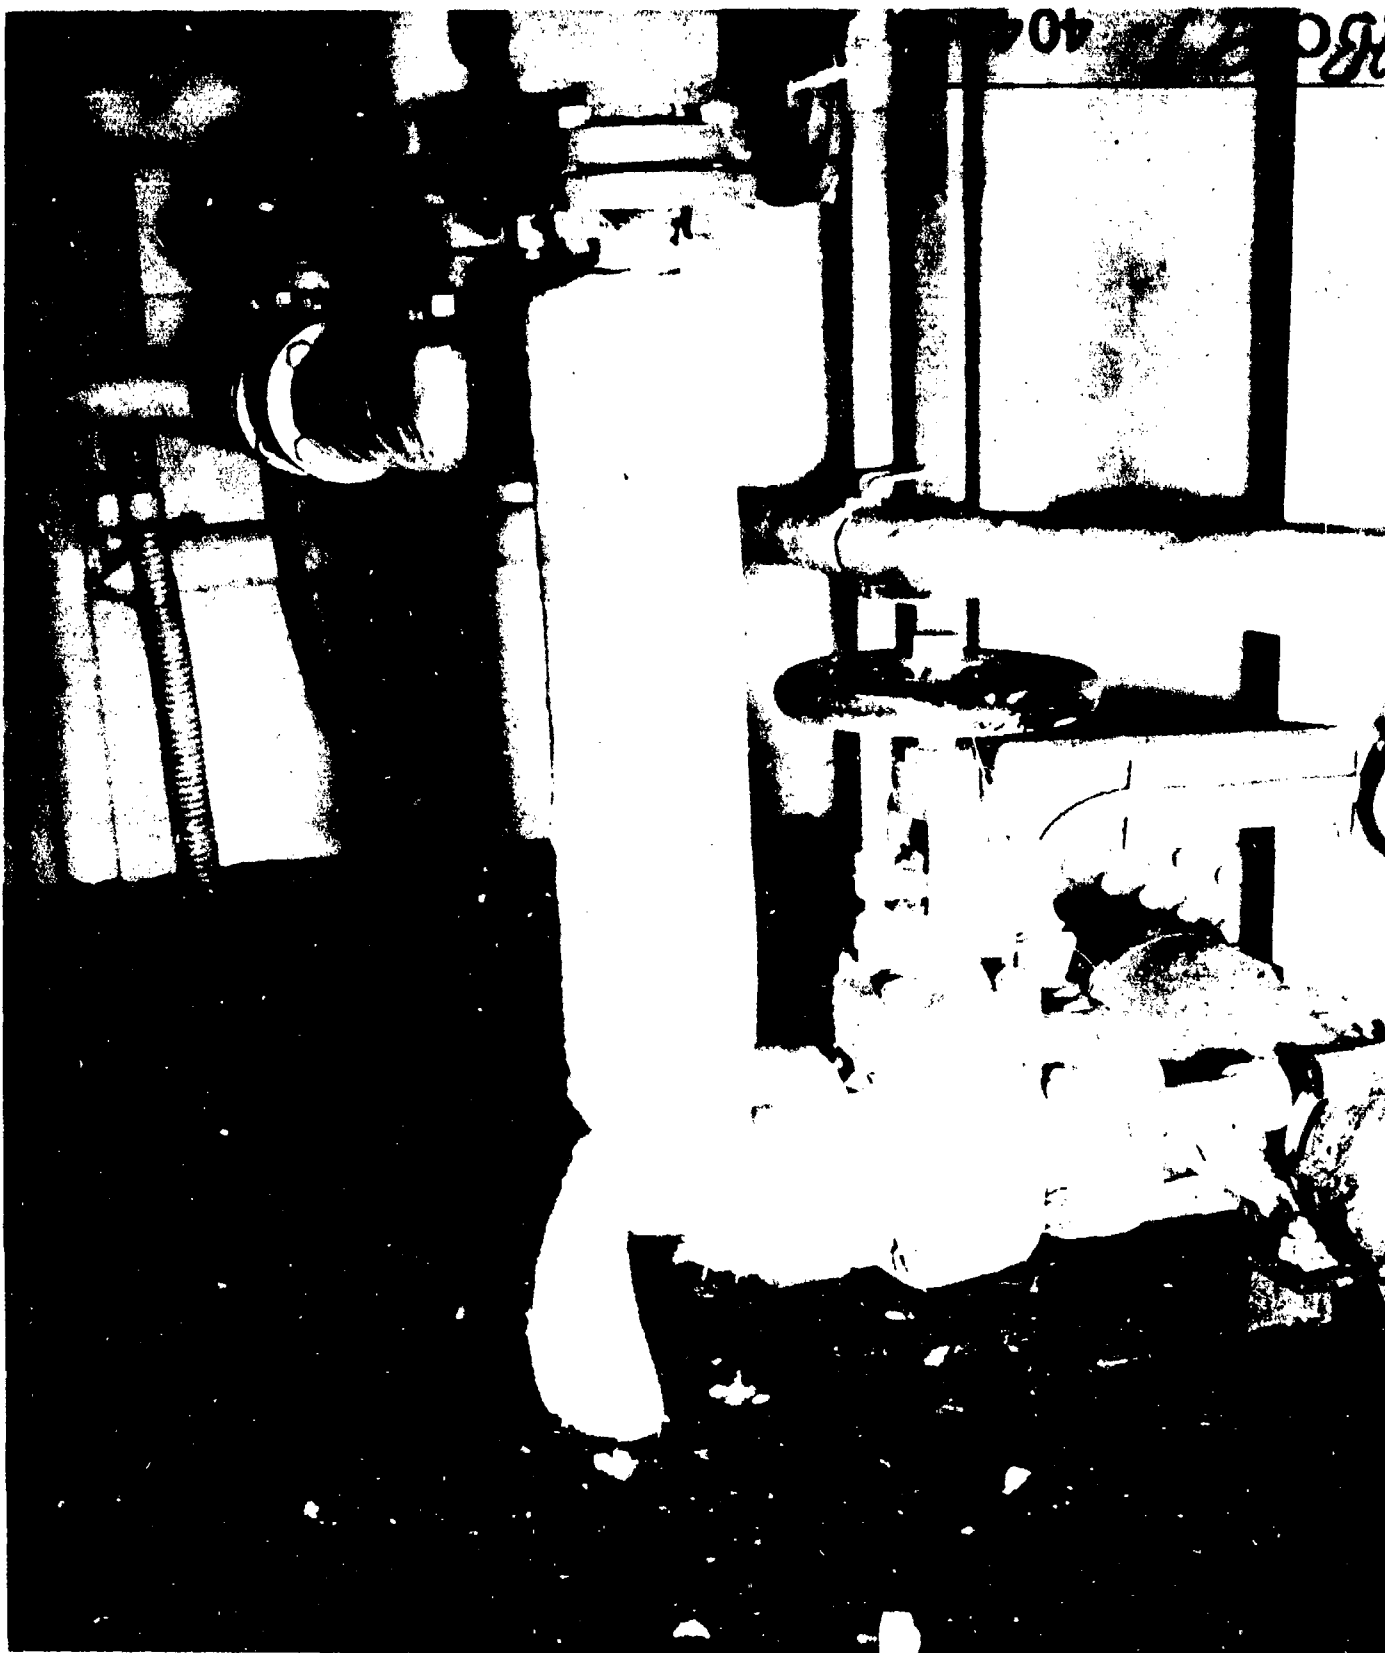
The hot water circulating pump mounted under the hot water heater in the forward engine room, had a broken discharge nozzle, caused by shock. (Photo 4044-5, page 50).

AB-CR-97-4044-5. No. 1 engine room, fresh water circulating pump.
